Infiniti 2010 G25x/G37x Sedan 4X4 17" Wheel

JN1CV6AR2AM450700

Wheel Alignment FAILED

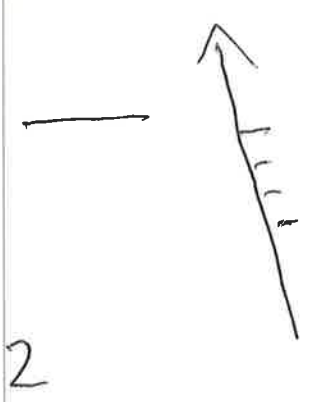
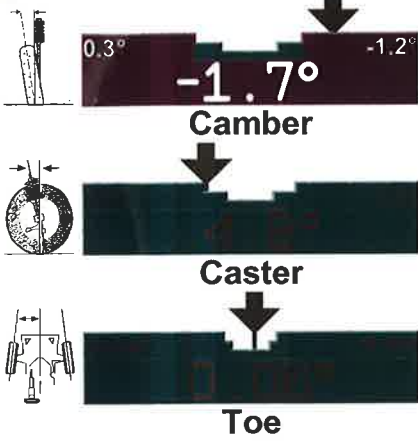
Left Front 89%
11/32in 11/32in 11/32in

- Excessive Camber could cause shoulder wear.
- Negative Camber could cause road shock or poor ride quality.

FRONT UPPER CONTROL ARMS

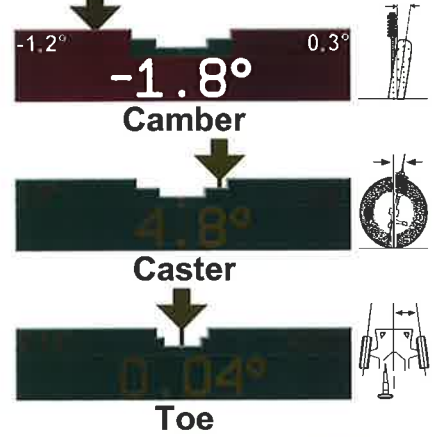
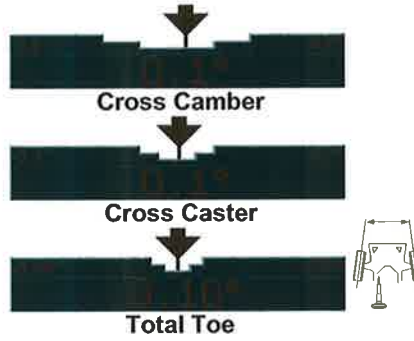
Right Front 62%
8/32in 11/32in 11/32in

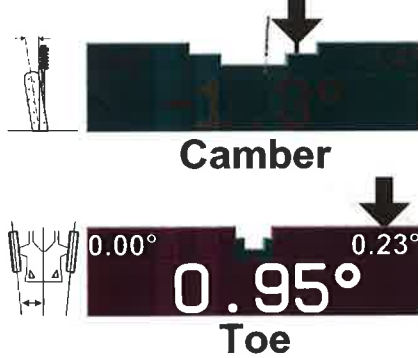
Left Rear 84%
10/32in 11/32in 10/32in

- Excessive Toe could cause scuffing or shoulder wear.
- Individual toe can not be adjusted.

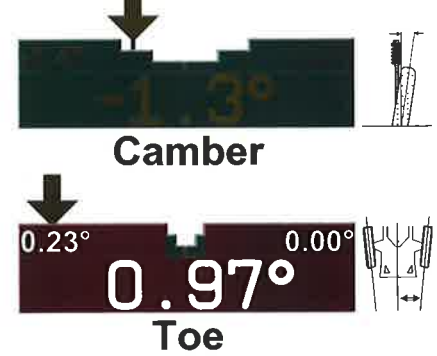
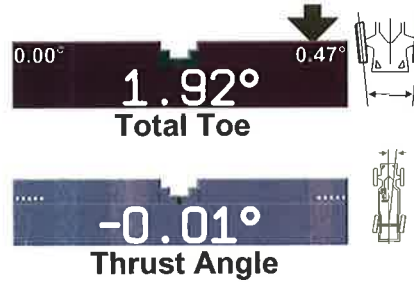
Right Rear 60%
7/32in 10/32in 10/32in
