**Classification:**  
 AT09-009b

**Reference:**  
 ITB09-032b

## 7 SPEED A/T HARSH 4>3 DOWNSHIFT ON DECELERATION

**APPLIED VEHICLES:**        2009 FX35 (S51) 2WD  
                                   2009 FX35/50 (S51) AWD  
                                   2009 G37 Sedan (V36) 2WD and AWD  
                                   2009 G37 Coupe (CV36) 2WD and AWD  
                                   2009 M35 (Y50) 2WD **ONLY**

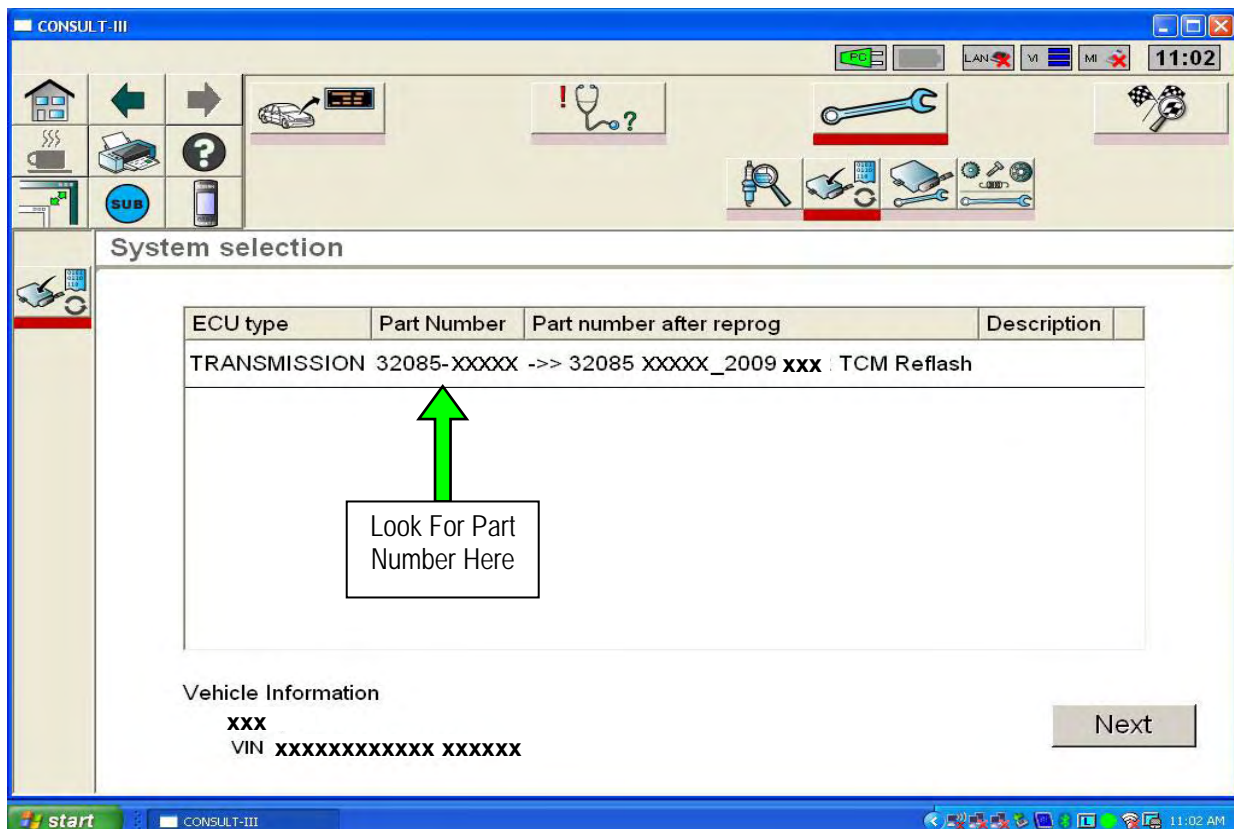
2. When you get to the TCM Reprogramming screen shown in Figure 1, confirm this bulletin applies as follows:
  - A. On your C-III screen, look at the **Part Number** column (see Figure 1 example).
    - If this column is **blank** (no part number listed), this **bulletin does not apply**.
    - If a Part Number (P/N) is listed, write it on the Repair Order and then go to Step B.

B. Compare the P/N you wrote down to the numbers in the **Current TCM P/N** column in **Table A** below.

- If there is a match this bulletin applies. Continue with the reprogramming procedure.

- If there is not a match this bulletin does not apply.

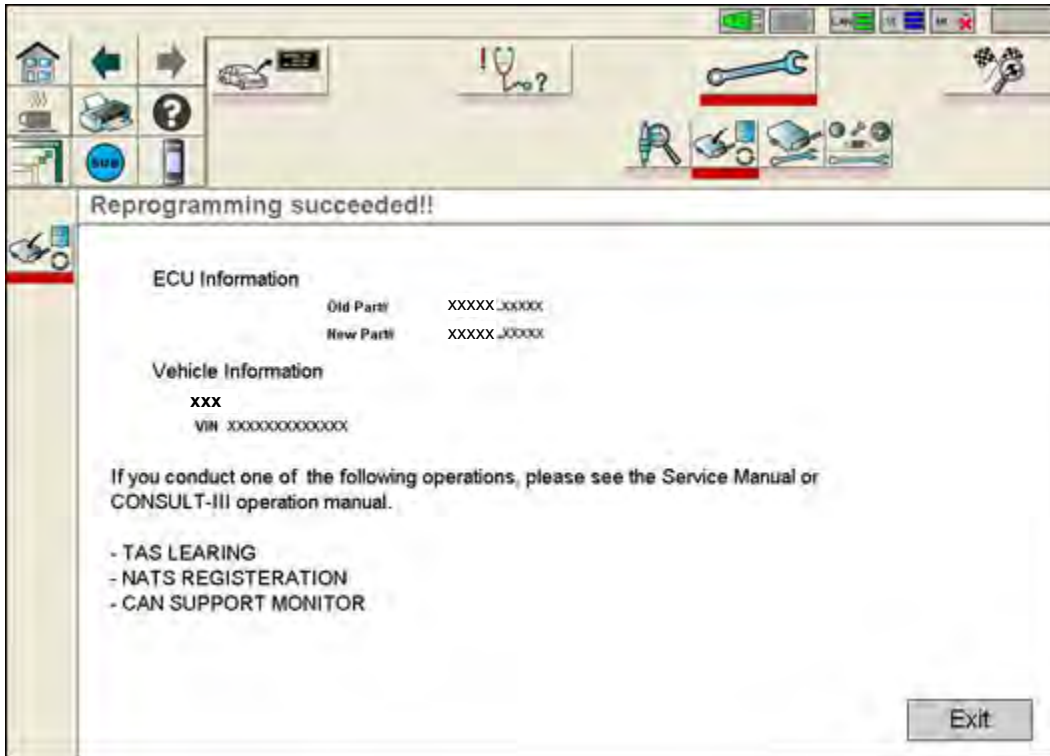
3. If this bulletin applies and you have performed TCM reprogramming; when reprogramming is complete, the screen in Figure 2 appears.

Print the page from C-III (C-III page example below) and attach it to the Repair Order for Warranty documentation.
