Classification:  
EL09-050b

## 2008 – 2009 G37 COUPE; BATTERY LOW VOLTAGE / NO START

**APPLIED VEHICLES:** 2008 – 2009 G37 Coupe (CV36)

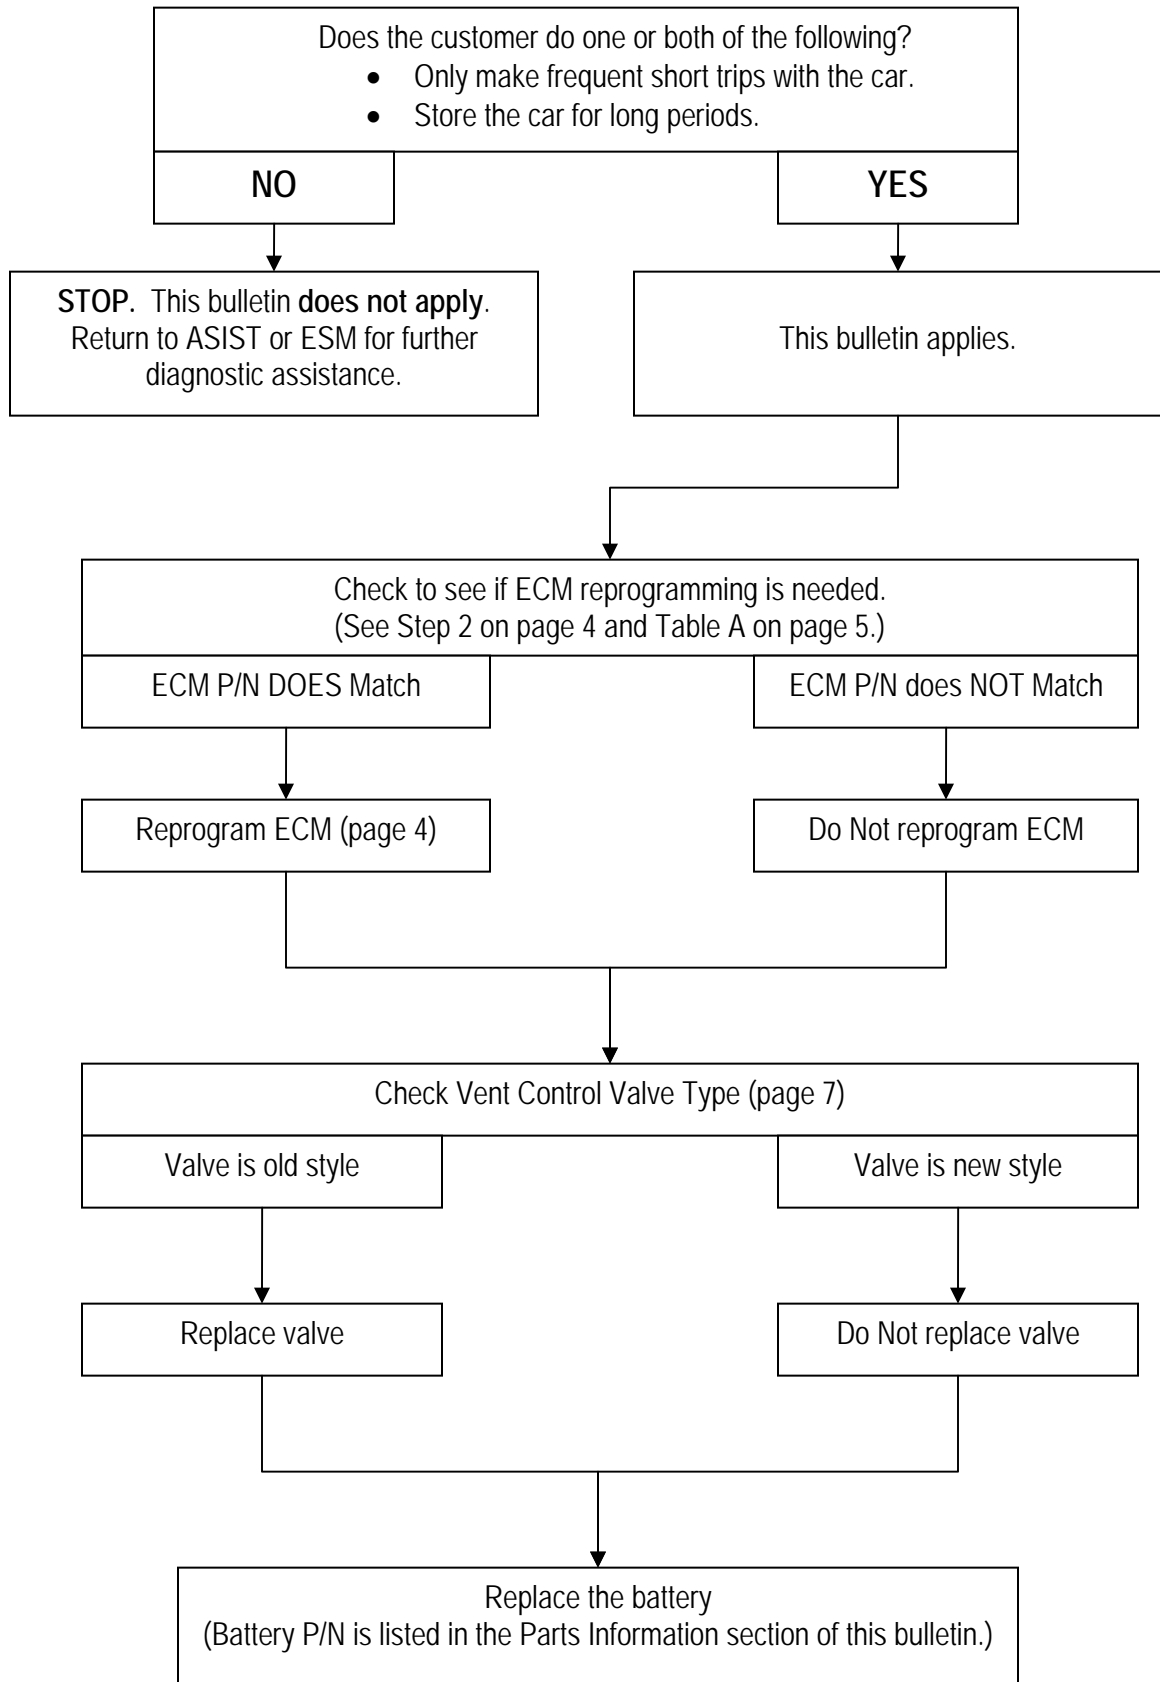
## Repair Overview

An Applied Vehicle has a “battery low voltage” or “no start condition” due to a specific customer use pattern (see **Repair Overview** on page 3 of this bulletin).

2. If this bulletin applies, use the **Repair Overview** flowchart on page 3 to determine which repair procedures to apply to your vehicle.

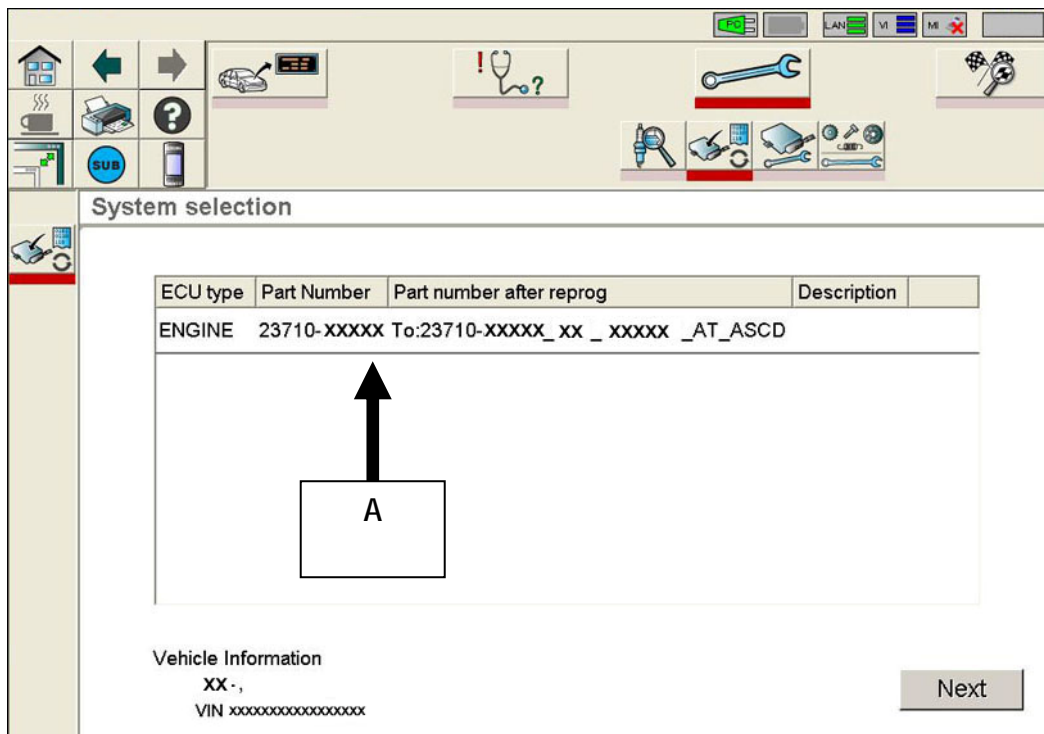
Figure 1

A. On your C-III screen, look at the Part Number column (see Figure 1)

- If this column is **blank** (no part number listed), proceed to **VENT CONTROL VALVE TYPE CHECK**
- If a Part Number is listed, write it on the Repair Order.

- B. Compare the Part Number you wrote down to the numbers in the **Current ECM Part Number** column in Table A.
- If there is a match, continue with the reprogramming procedure.
  - If there is not a match, proceed to **VENT CONTROL VALVE TYPE CHECK**.

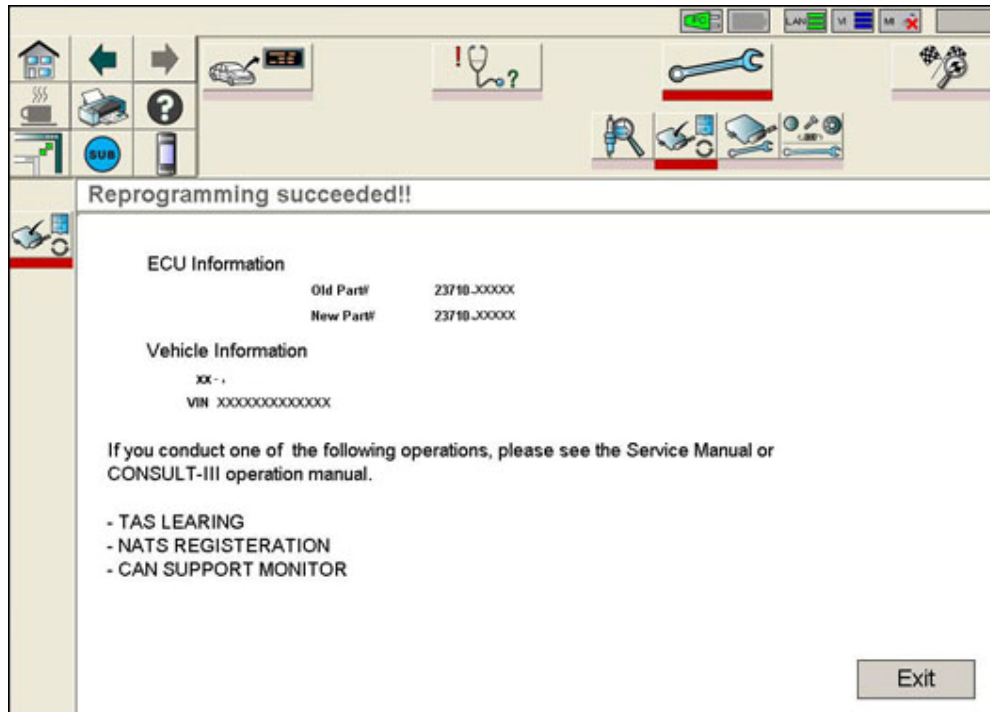
3. If you have performed ECM reprogramming, the screen in Figure 2 appears when reprogramming is complete.

Print this page and attach it to the Repair Order for Warranty documentation.
