BT10-038a

May 16, 2011

2009 - 2011 G37 CONVERTIBLE; WATER LEAK AT WINDSHIELD HEADER AREA

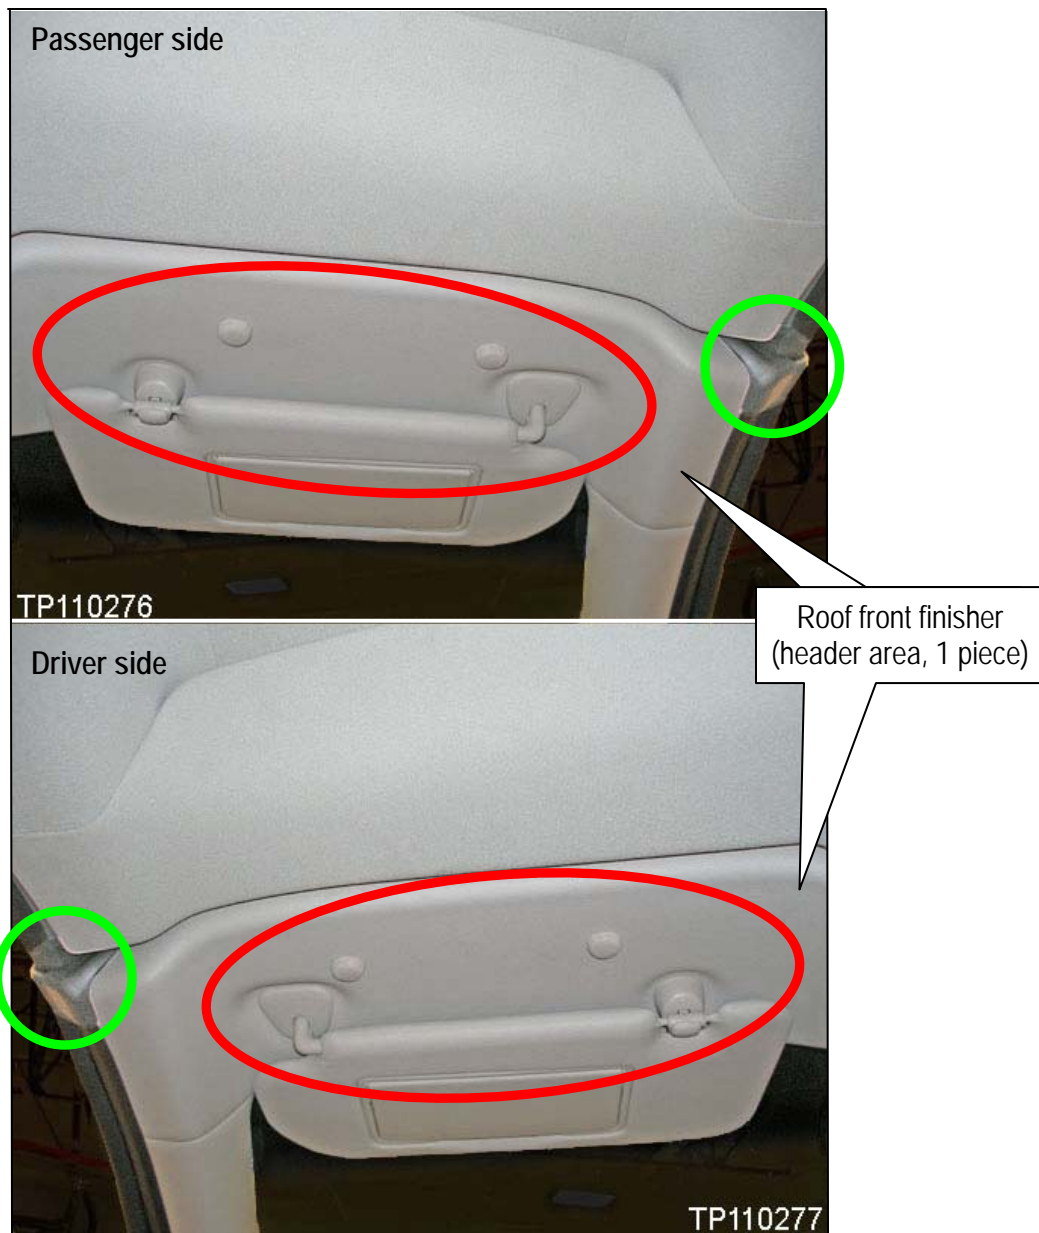
Repair Flow Chart

Verified: Water is leaking from the top of the windshield header area

Leaks from one or both areas circled in **RED**: Perform Procedure A (Page 3)

Leaks from one or both areas circled in **GREEN**: Perform Procedure B (Page 4)
