Classification:
HA07-001b**Reference:**
ITB07-007b**Date:**
June 3, 2008

G35 / G37 / EX35; TAPPING NOISE FROM DASH AREA WHEN ENGINE IS RUNNING

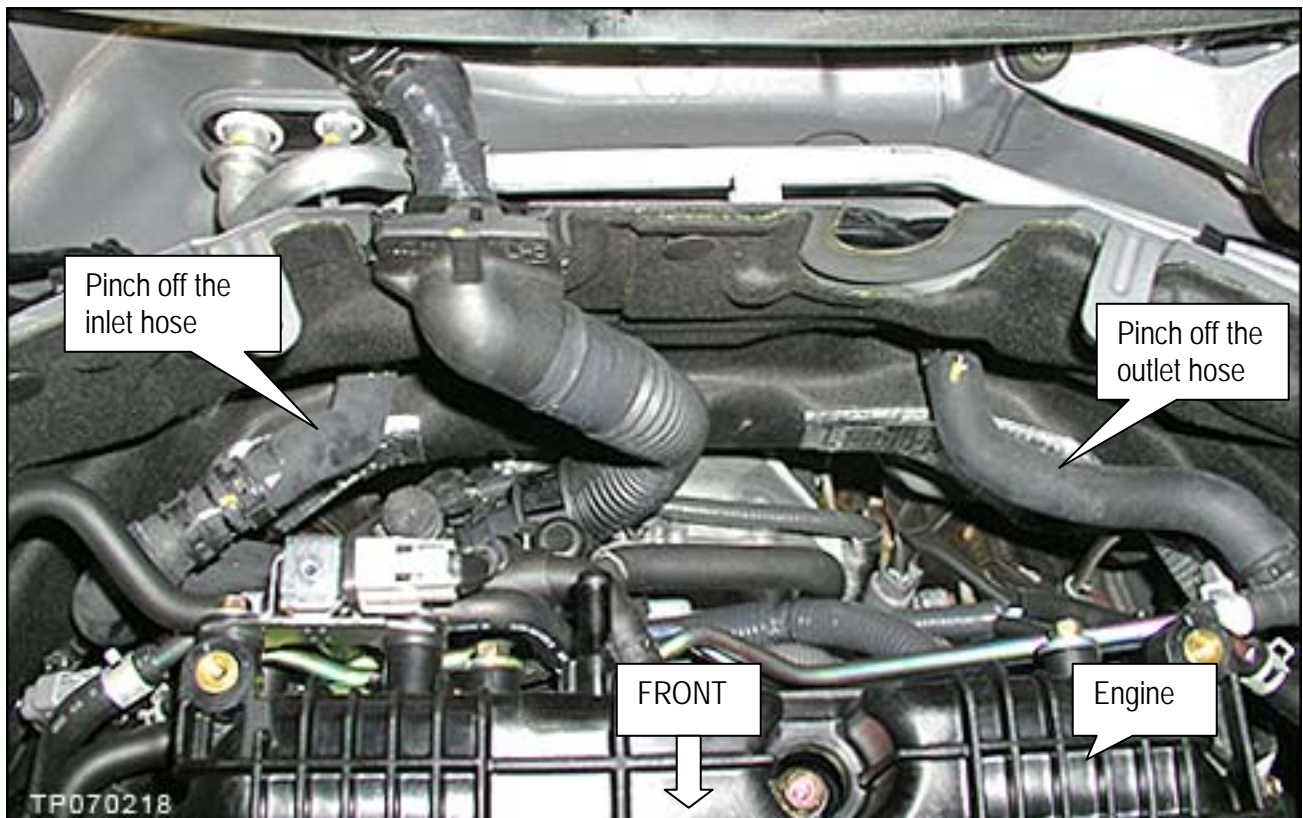
Figure 1

1. Confirm the noise is coming from the heater core as follows:
 - a. Confirm the engine is at operating temperature.
 - b. Turn the engine OFF.
 - c. Use blunt pinch clamps to pinch the heater core inlet and outlet hoses; this will stop the water flow through the heater core.
 - d. Start the engine and check for the noise; gradually increase engine RPM to 3500.

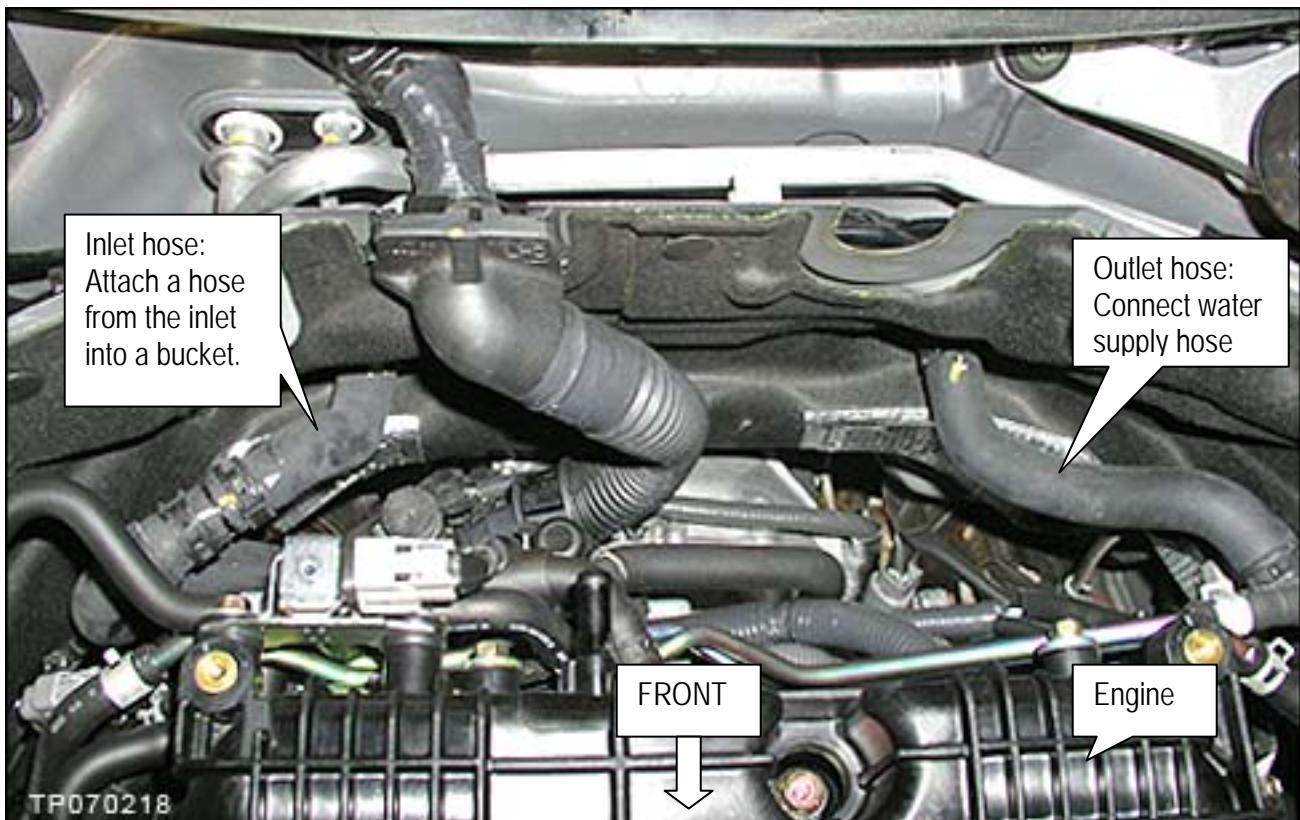
Figure 2

3. Look in the bucket to find the silicone debris (long piece or balled-up piece of gray silicone).
 - If you find the silicone, back-flush is finished.
 - If you don't find the silicone, repeat step 2 (back-flush) until you find silicone debris in the collection bucket.

2. "Back-Flush" the heater core as follows:
 - a. Follow Service Manual procedures (section CO) to drain the cooling system.
 - b. Disconnect the heater core inlet and outlet hoses.
 - c. Connect a water hose (garden hose) to the heater core outlet.

- d. Connect a hose from the heater core inlet side into a clean bucket (minimum 5 gallon bucket recommended).

- e. Turn ON the water supply.
 - f. Let the water flow (back-flush) thought the heater core until the bucket is full.
