EC08-010

## 2008 G37 COUPE; NOISE FROM BANK 2 VVEL ACTUATOR

**APPLIED VEHICLE:** 2008 G37 Coupe (CV36)

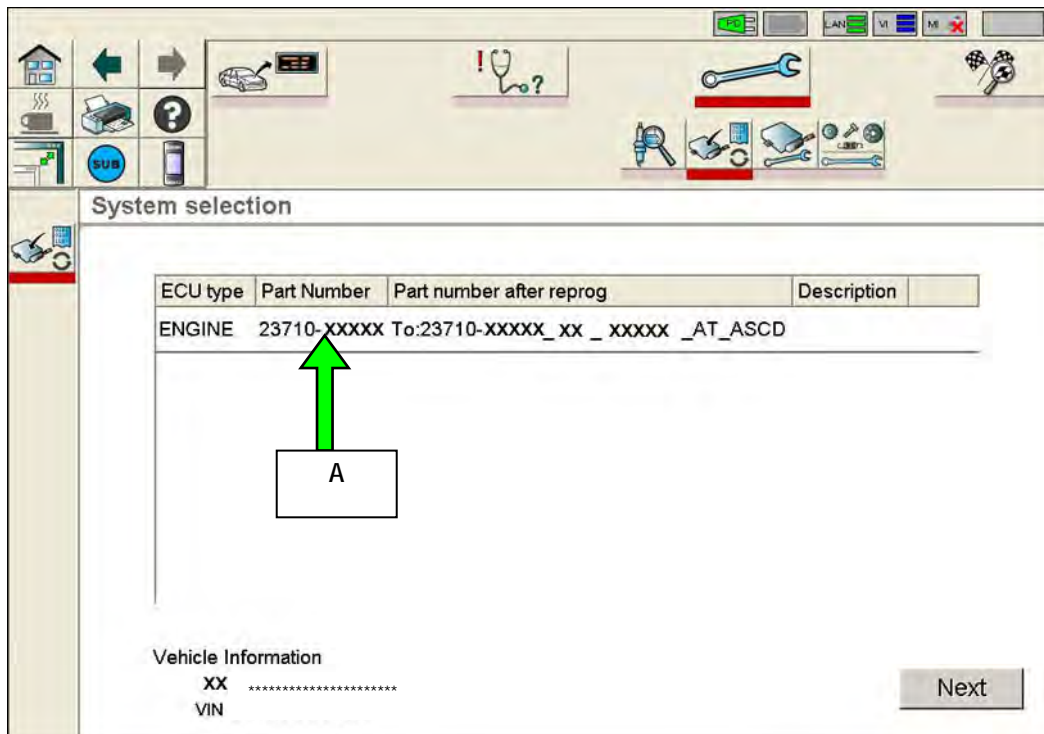
Figure 1

1. Connect C-III to the vehicle to begin the reprogramming procedure.
  - If you are not familiar with the reprogramming procedure, click here. This will link you to the "CONSULT- III (C-III) ECM Reprogramming" general procedure.
2. When you get to the ECM Reprogramming screen shown in Figure 1, confirm this bulletin applies as follows:
  - A. On your C-III screen, look at the **Part Number** column (see Figure 1):
    - If this column is **blank** (no part number listed), this **bulletin does not apply**. Close C-III and refer to ASIST for further diagnostic information.
    - If a Part Number is listed, write it on the Repair Order.

C. Compare the Part Number you wrote down to the numbers in the **Current ECM Part Number** column in Table A.

- If there is a match, this bulletin applies; continue with the reprogramming procedure.

- If there is not a match, this bulletin does not apply. Close C-III and refer to ASIST for further diagnostic information.

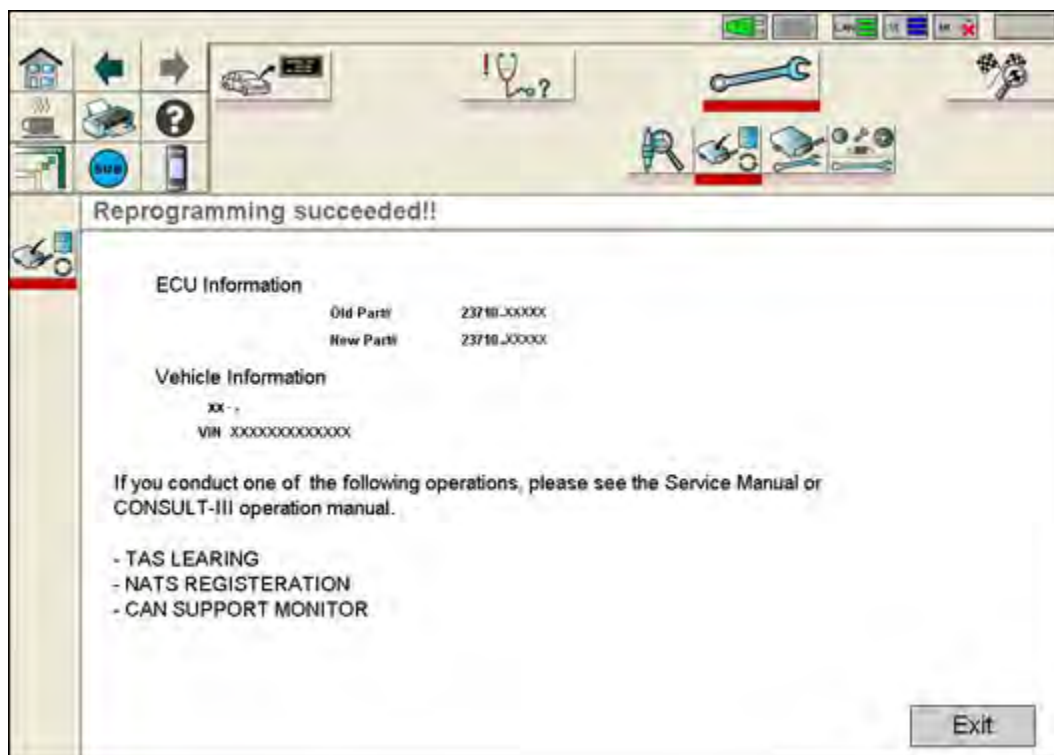
**Figure 2**

3. If this bulletin applies and you have performed ECM reprogramming, the screen in Figure 2 displays when the reprogramming is completed.

Print this screen and attach it to the Repair Order for Warranty documentation.
