AT12-003d

November 14, 2012

2009 - 2012 G37; SHIFT RESPONSIVENESS ISSUES

APPLIED VEHICLES: 2009 – 2011 G37 Sedan and Coupe (V36/CV36)
 2009 – 2012 Convertible (HV36)
APPLIED ENGINE: VQ37VHR
APPLIED TRANSMISSION: 7 speed

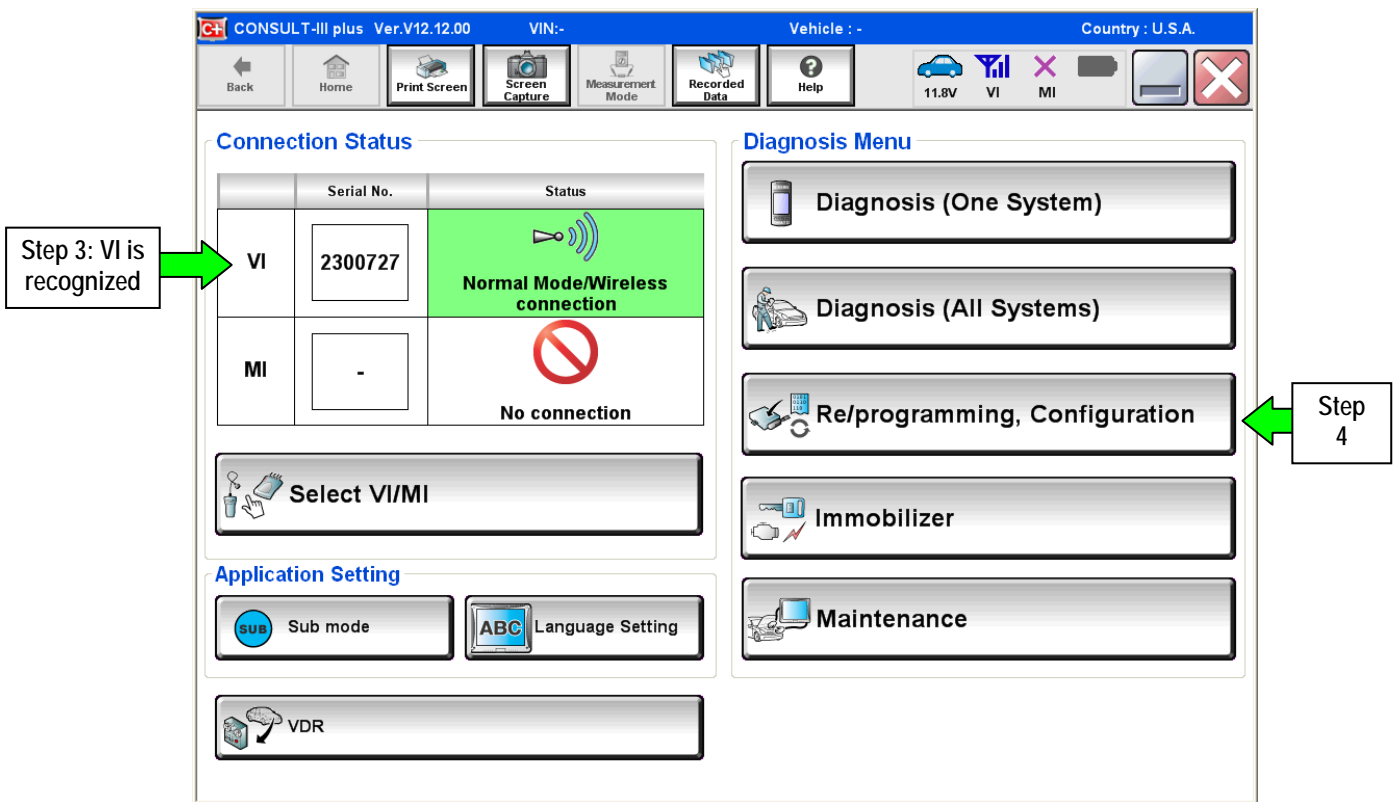
Figure 1

1. Connect the CONSULT PC to the vehicle to begin the reprogramming procedure.
2. Open ASIST on the CONSULT PC and start C-III plus.
3. Wait for the plus VI to be recognized / connected.
 - Serial number will display when the plus VI is recognized / connected.
4. Select Re/programming, Configuration.

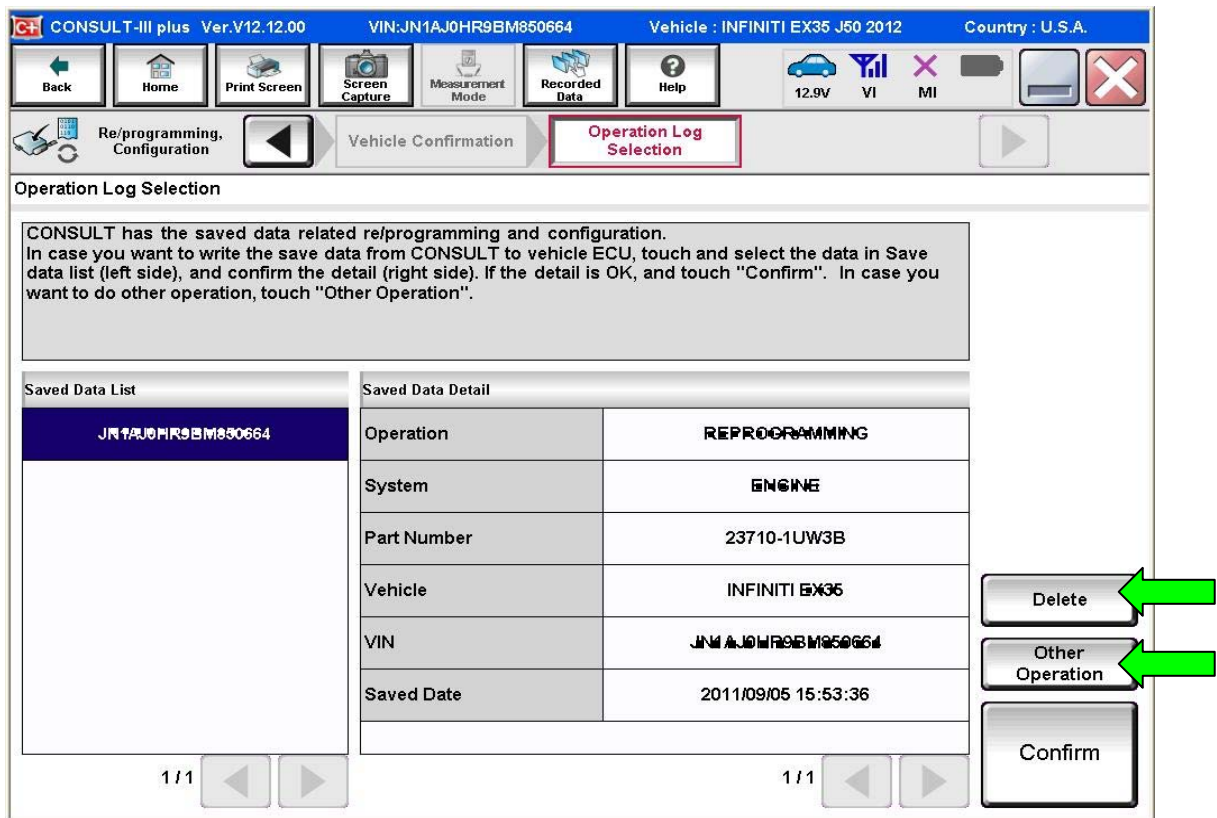
While navigating C-III plus, if the screen in Figure 1A displays, select **Delete** and then **Other Operation**.

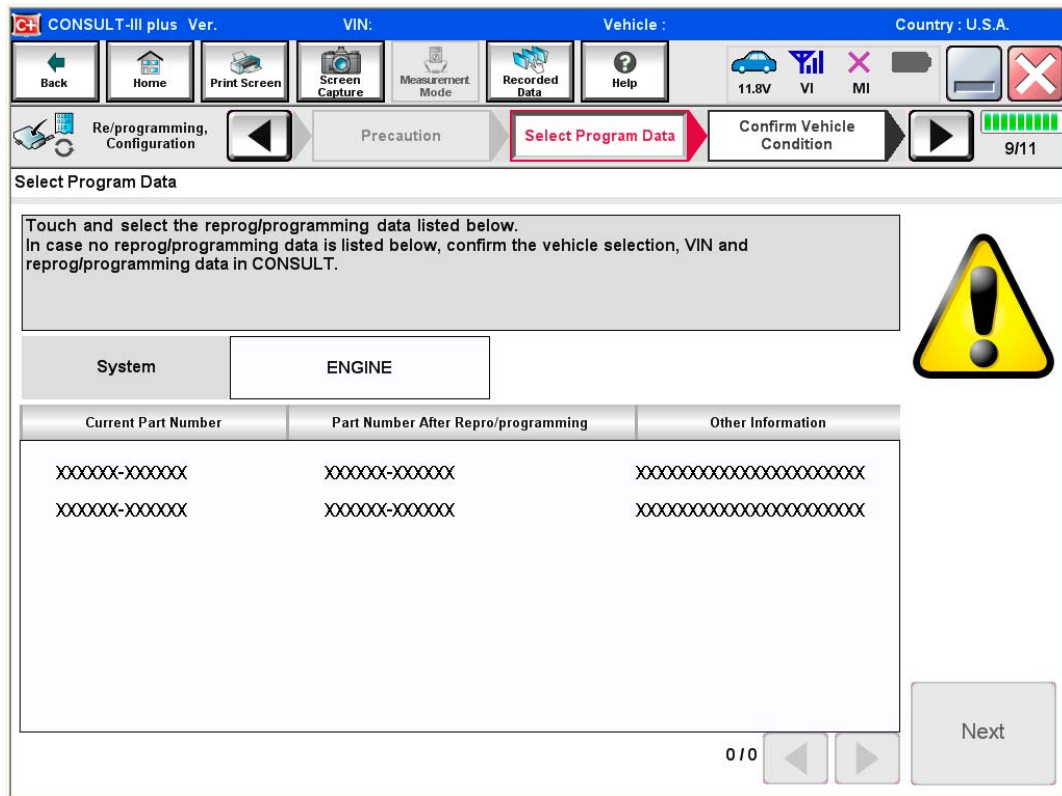
- In some cases, more than one new P/N for reprogramming is available.
 - In this case, the screen in Figure 3 displays.
 - Select and use the reprogramming option that **does not** have the message “Caution! Use ONLY with ITBXX-XXX”.
- If you get this screen and it is blank (no reprogramming listed), it means there is no reprogramming available for this vehicle.

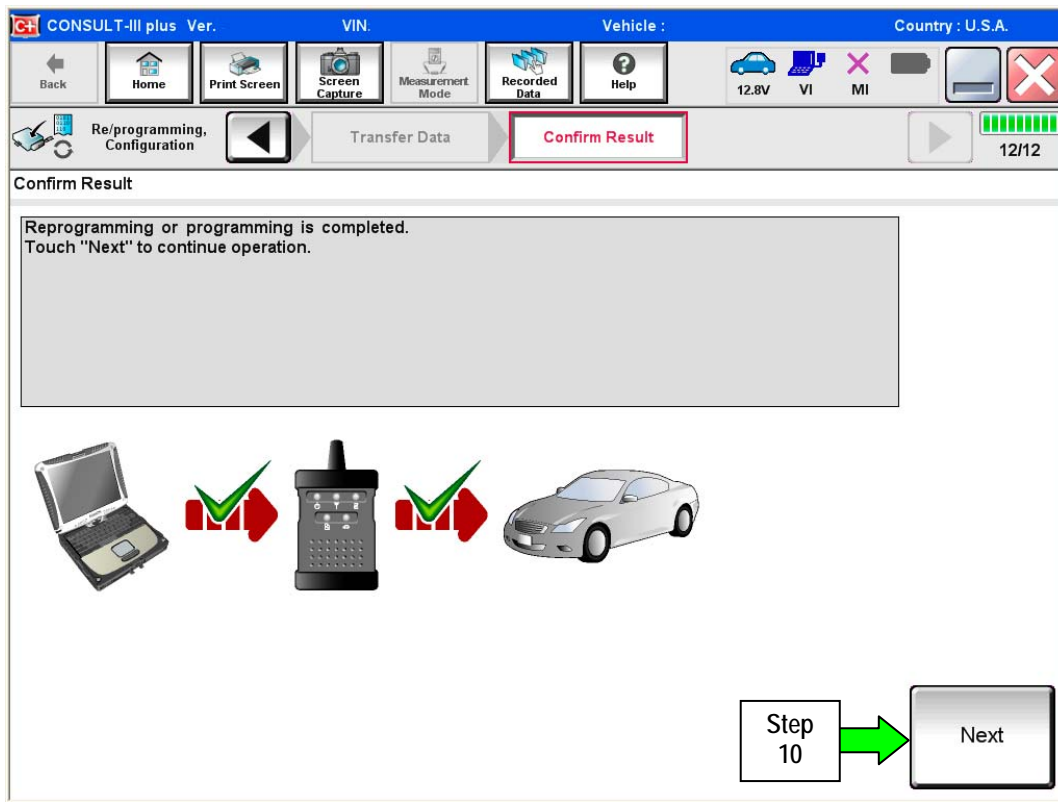
8. When the screen in Figure 4 displays, reprogramming is complete.

NOTE: If the screen in Figure 4 does not display (reprogramming does not complete), refer to the information on the next page.

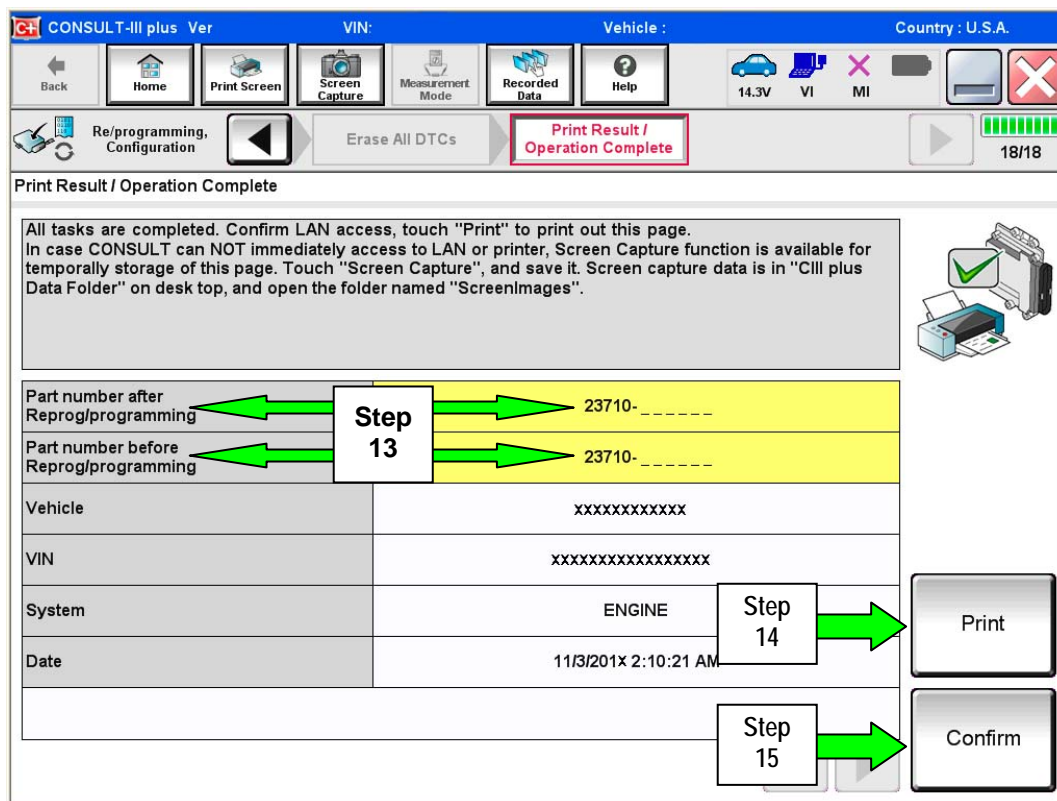
12. When the entire reprogramming process is complete, the screen in Figure 7 will display.
13. Verify the before and after part numbers are different.
14. Print a copy of this screen (Figure 7) and attach it to the repair order for warranty documentation.
15. Select **Confirm**.
