Revision: 2009 November IP-5 2010 G37 Sedan

INSTRUMENT PANEL ASSEMBLY A/T MODELS

A/T MODELS: Exploded View

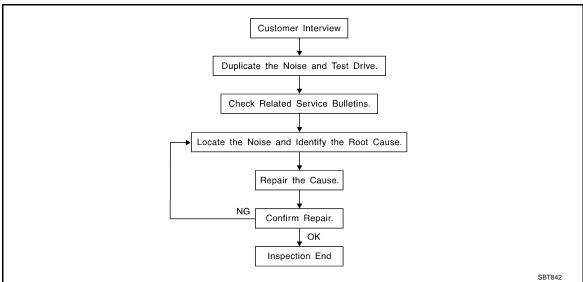
Work Flow

CUSTOMER INTERVIEW

Interview the customer if possible, to determine the conditions that exist when the noise occurs. Use the Diagnostic Worksheet during the interview to document the facts and conditions when the noise occurs and any of customer's comments; refer to <u>IP-10</u>, "<u>Diagnostic Worksheet</u>". This information is necessary to duplicate the conditions that exist when the noise occurs.

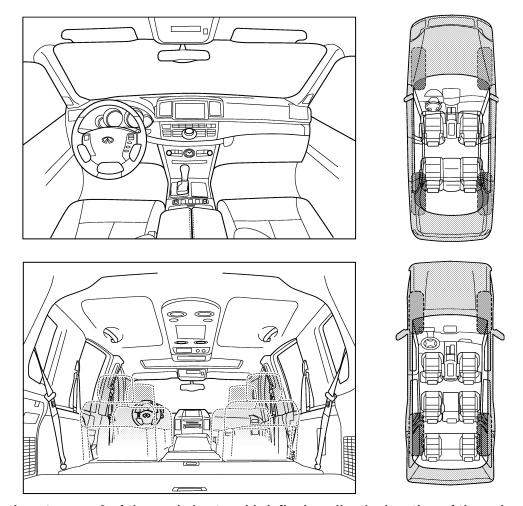
I. WHERE DOES THE NOISE COME FROM? (circle the area of the vehicle)

The illustrations are for reference only, and may not reflect the actual configuration of your vehicle.

Continue to page 2 of the worksheet and briefly describe the location of the noise or rattle. In addition, please indicate the conditions which are present when the noise occurs.

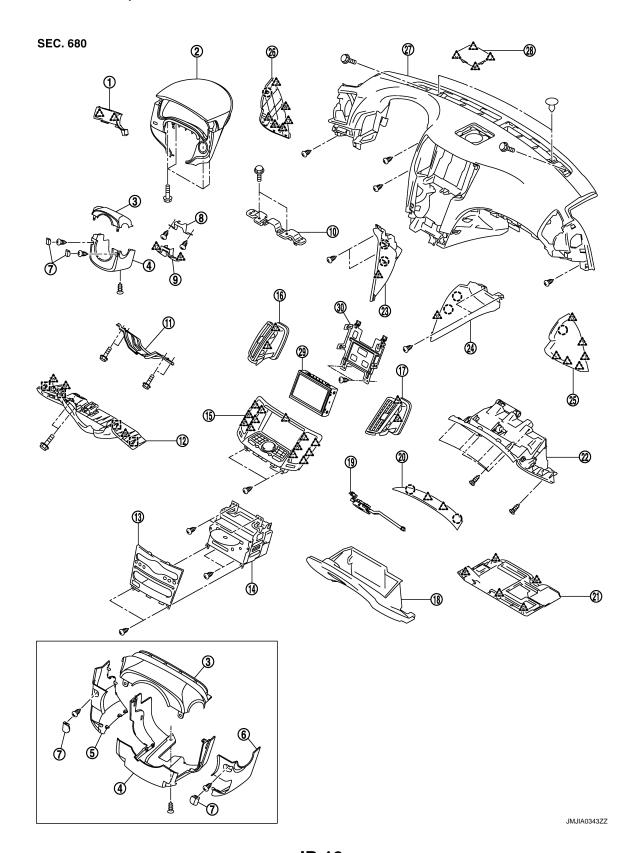
1. Instrument finisher A 2. Cluster lid A (Combination meter) 3. Steering column cover upper 4. Steering column cover lower 5. Steering column side cover LH 6. Steering column side cover RH 7. Steering column mask 8. Cluster lid A lower bracket 9. Steering column front lower cover 10. Meter bracket Knee protector 12. Instrument lower panel LH 13. Cluster lid C 14. AV control unit Cluster lid D 16. Center ventilator grille LH Center ventilator grille RH 17. 18. Glove box assembly 19. Glove box lock assembly 20. Instrument finisher B 21. Instrument lower cover 22. Instrument lower panel RH 23. Instrument side panel LH 24. Instrument side panel RH 25. Instrument side finisher RH 26. Instrument side finisher LH 27. Instrument panel assembly 28. Center speaker grille 29. Display unit 30. Display unit bracket : Clip

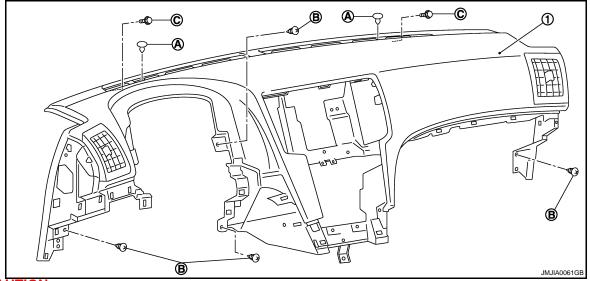
- 42. Disconnect front passenger air bag module connector. Refer to SR-17, "Removal and Installation".
- 43. Remove front passenger air bag module fixing bolt. Refer to SR-17, "Removal and Installation".
- 44. Remove instrument panel assembly.
 - Remove defroster nozzle mounting clips (A).
 - Remove screws (B) and bolts (C) with power tool, and then remove instrument panel assembly (1).

- Cover tool with a shop cloth to prevent windshield glass being damaged.
- When removing instrument panel, 2 workers are required so as to prevent it from dropping.
- 45. Remove the following parts after removing instrument panel assembly.
 - Center speaker: Refer to <u>AV-480</u>, "Removal and Installation".
 - Front passenger air bag module: Refer to SR-17, "Removal and Installation".
 - Side ventilator grille LH/RH: Refer to VTL-11, "SIDE VENTILATOR GRILLE: Removal and Installation".
 - Inside key antenna: Refer to DLK-252, "INSTRUMENT CENTER: Removal and Installation".
 - Combination meter: Refer to MWI-135, "Removal and Installation".
 - Center speaker grille
 - Antenna feeder

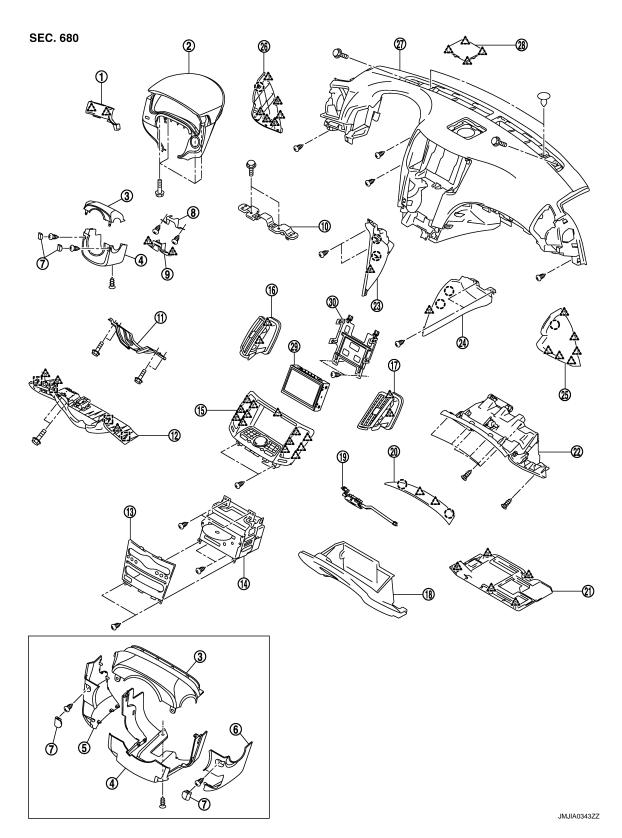
M/T MODELS: Exploded View

- 1. Instrument finisher A
- 4. Steering column cover lower
- 2. Cluster lid A (Combination meter)
- 5. Steering column side cover LH
- 3. Steering column cover upper
- 6. Steering column side cover RH

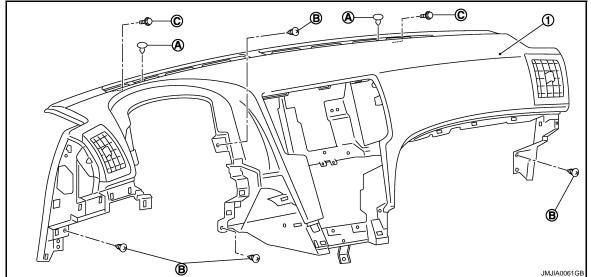
- 42. Disconnect front passenger air bag module connector. Refer to SR-17, "Removal and Installation".
- 43. Remove front passenger air bag module fixing bolt. Refer to SR-17, "Removal and Installation".
- 44. Remove instrument panel assembly.
 - Remove defroster nozzle mounting clips (A).
 - Remove screws (B) and bolts (C) with power tool, and then remove instrument panel assembly (1).

- Cover tool with a shop cloth to prevent windshield glass being damaged.
- When removing instrument panel, 2 workers are required so as to prevent it from dropping.
- 45. Remove the following parts after removing instrument panel assembly.
 - Center speaker: Refer to AV-480, "Removal and Installation".

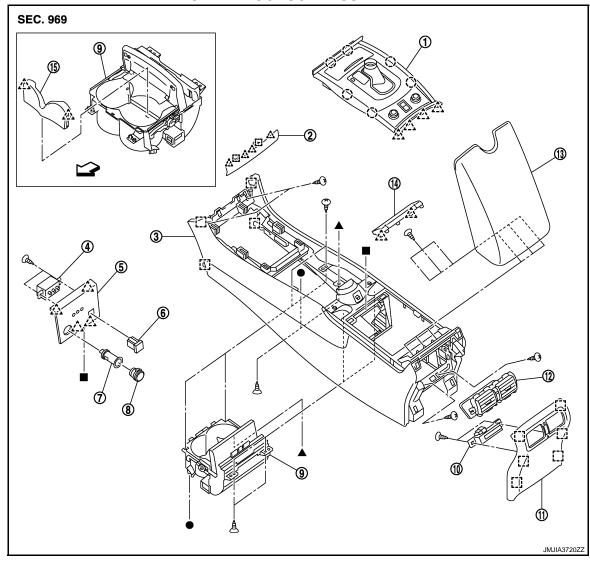
CENTER CONSOLE ASSEMBLY

- 1. Console finisher assembly
- 4. Auxiliary input jacks (if equipped)
- 7. Power socket Inner case
- 10. Inside key antenna
- 13. Console lid assembly
- (_) : Clip
- 八:Pawl
- [] : Metal clip
- : Vehicle front

- 2. Instrument finisher E
- 5. Console center finisher
- 8. Socket knob
- 11. Console rear finisher
- 14. Console mask

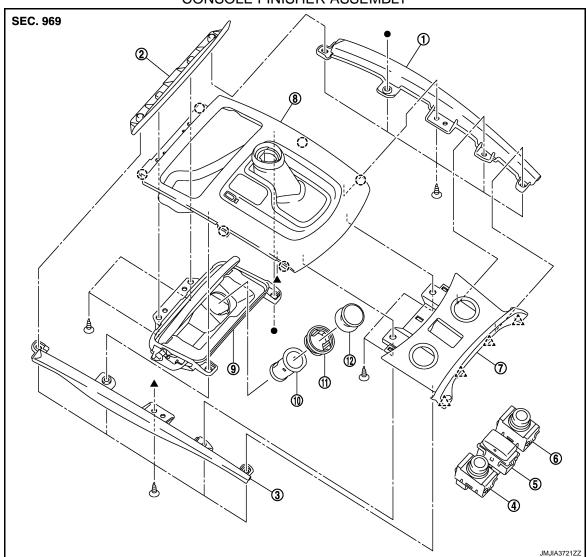
CONSOLE FINISHER ASSEMBLY

- Console finisher escutcheon RH
- Heated seat switch (driver side) (if equipped)
- 7. Switch panel
- 10. Power socket Inner case or Cigarette lighter case
- : Clip 八: Pawl

- 2. Console front finisher
- Switch (if equipped)
- 8. AT control indicator assembly
- 11. Socket ring

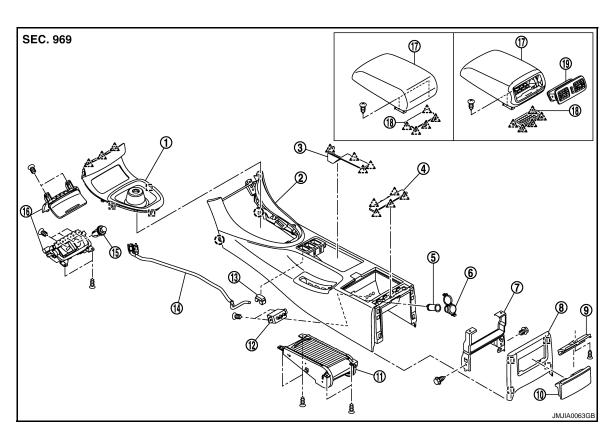
M/T MODELS: Exploded View

- 1. Console finisher assembly
- 4. Console mask
- 7. Console rear bracket
- 10. Console ashtray
- 13. Switch hole mask
- 16. Ashtray (front) or Coin pocket
- 19. Rear ventilator grille
- () : Clip
- _ △、: Pawl
- : Metal clip

- 2. Center console assembly
- 5. Power socket (if equipped)
- 8. Console rear finisher
- 11. Cup holder assembly
- 14. Console sub harness
- 17. Console lid
